MONOTONIC AND FATIGUE BEHAVIOR OF  
2-D WOVEN CERAMIC MATRIX COMPOSITE  
AT ROOM AND ELEVATED TEMPERATURES  
(BLACKGLAS/NEXTEL 312)

THESIS

MUSA AL-HUSSEIN  
LT.COL., ROYAL JORDANIAN AIR FORCE  
AFIT/GAE/ENY/98S-01

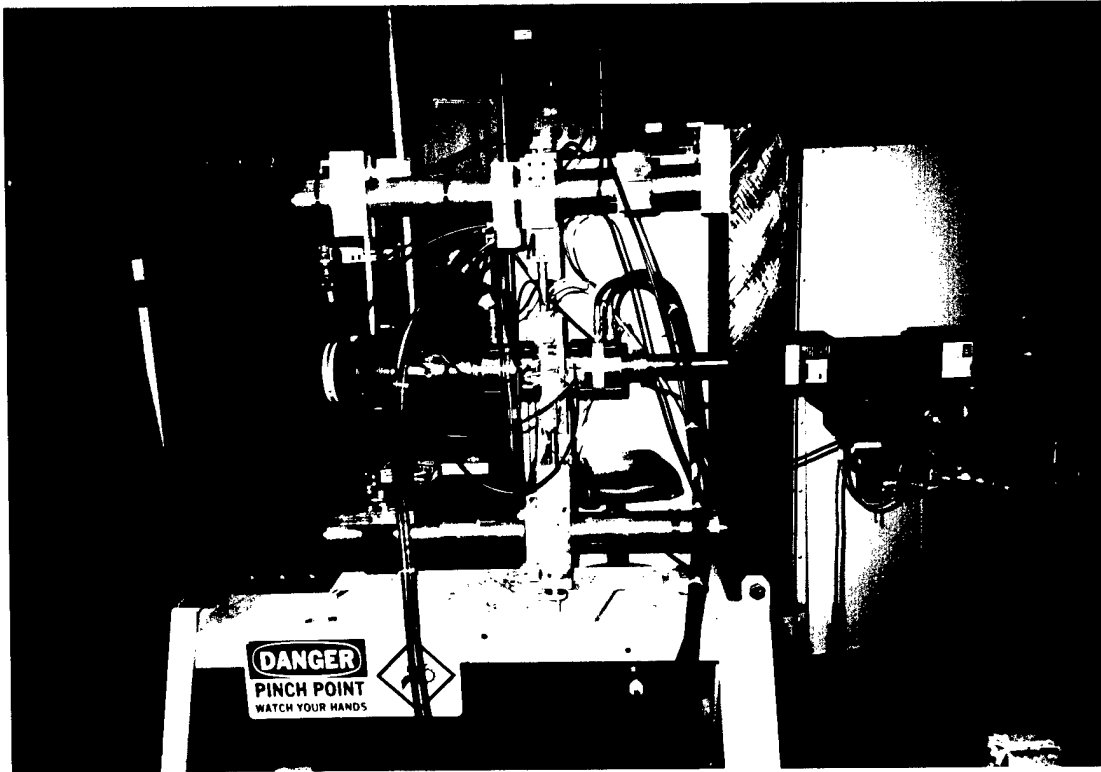
**Figure 3.2** 22.4KN Material Test System (MTS) horizontal tensile tester

MTS 647 hydraulic wedge grips. The cooling water also cooled the heat lamps and the isolation block between the grip wedge assemblies and the model 661.20E-01 force transducer. The heat lamps also had internal airflow to improve heat dissipation.

The hydraulic grip wedge assemblies were operated by means of an MTS 685 hydraulic grip supply. Tensile, and compressive pressure was applied to the specimen through a model 244.12 hydraulic actuator. Displacement of the test specimen was measured using an MTS 632.52E-14 extensometer. The extensometer gauge length was 12.0 mm, and it was calibrated to display 0.02648 full scale displacement. Monitoring and control functions were provided through an MTS model 458.2 microconsole, with appropriate displacement, force, and strain plug-ins. Some feedback signals had to be

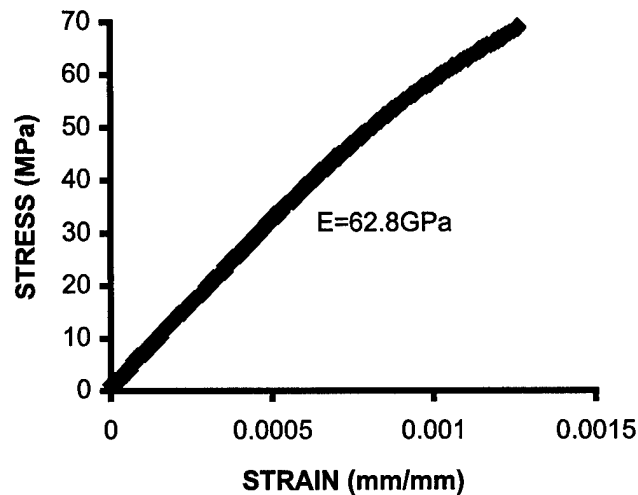
**Figure 4.1** Room Temperature Monotonic Tensile Test

This graph shows a linear stress-strain relationship from the onset of loading up to about 44MPa stress level, after which the relation became nonlinear until the specimen broke at a maximum stress of 69.4MPa, and a maximum strain of 0.1261%. The Young's modulus is the slope of the initial linear region of the stress-strain curve and is found to be 62.8GPa.

This test was conducted at room temperature (20°C). The specimen was loaded under tension until it broke. Figure 4.1 shows the stress-strain curve.

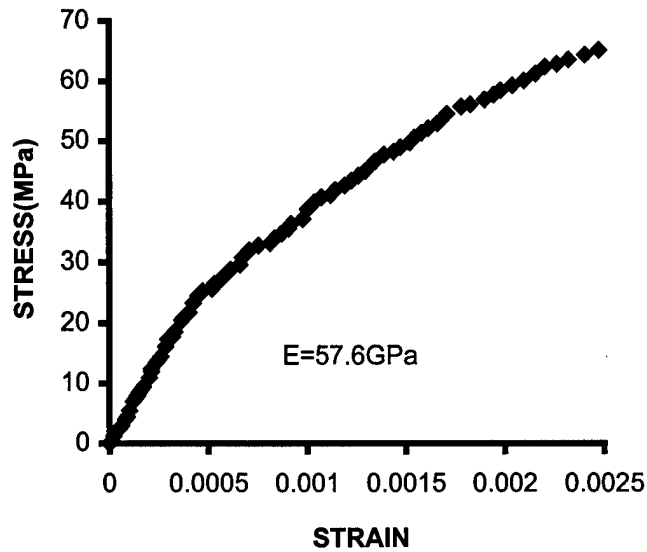
**Figure 4.2** Elevated Temperature Monotonic Tensile Test

It can be seen that the stress-strain relationship is linear up to about 24MPa, which is the proportional limit, then the curve becomes non-linear and shows a lower slope. The Young's modulus of elasticity calculated from the linear region up to the proportional limit is 57.6GPa, and the slope in the non-linear region is 23.2GPa. This is an indication that damage had occurred in the specimen. The damage mechanisms will be discussed in section 6 of this chapter. The failure stress in this test was 65.2MPa, which is slightly lower than the room temperature value. The failure strain was 0.2474%, which is about twice as much as the room temperature test failure strain. These values of failure stress & failure strain indicate that the elevated temperature has little effect on the maximum stress the material can withstand before it fails, and the material can withstand higher values of strain before it fails under elevated temperature conditions.

This test was carried out at 760°C. The temperature was allowed to stabilize for more than 15 minutes before the test was started. The specimen was loaded until it failed. Figure 4.2 shows the stress-strain relationship for this test.

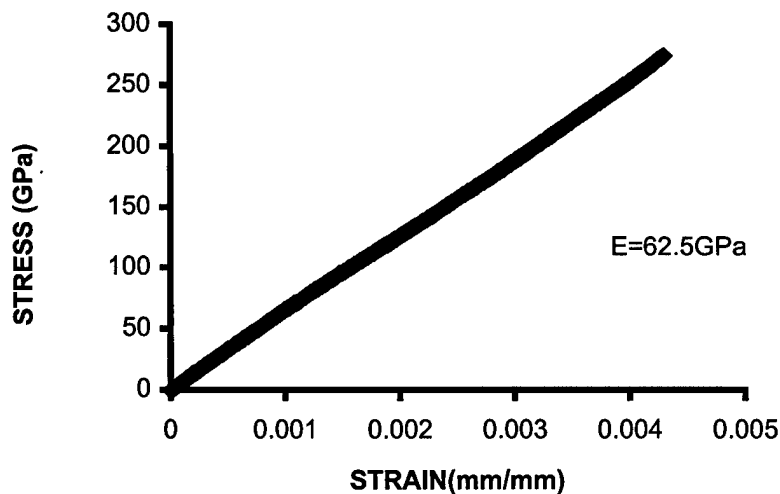
Figure 4.3 Room Temperature Monotonic Compression Test

This test was performed at room temperature. The specimen was loaded in compression until failure. The test specimen had been cut to a short length (about 11.43cm) to alleviate non-axial loads that would have adversely affected the test results. Figure 4.3 shows the stress-strain relationship for this test. It can be seen that the stress-strain relationship remained linear until failure, which occurred at a stress level of 273.9MPa. The failure strain was 0.43%. The Young's modulus of elasticity obtained from this test is 62.5GPa.

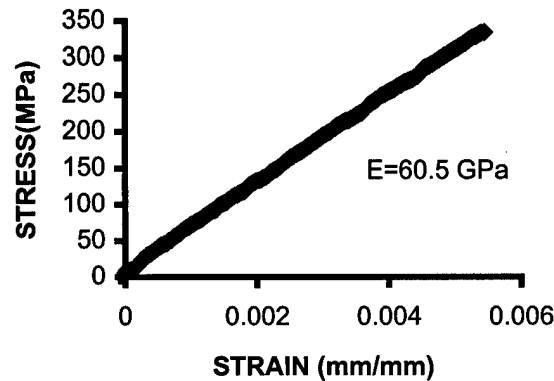
**Figure 4.4** Elevated Temperature Monotonic Compression Test

The stress-strain relationship as can be seen from the above graph is linear up to failure. The maximum compressive stress at failure was 334.5MPa, and the failure strain was 0.5446%. The Young's modulus of elasticity obtained from this test is 60.5GPa.

This test was carried out at 760°C. Figure 4.4 Shows the stress-strain relationship for this test.

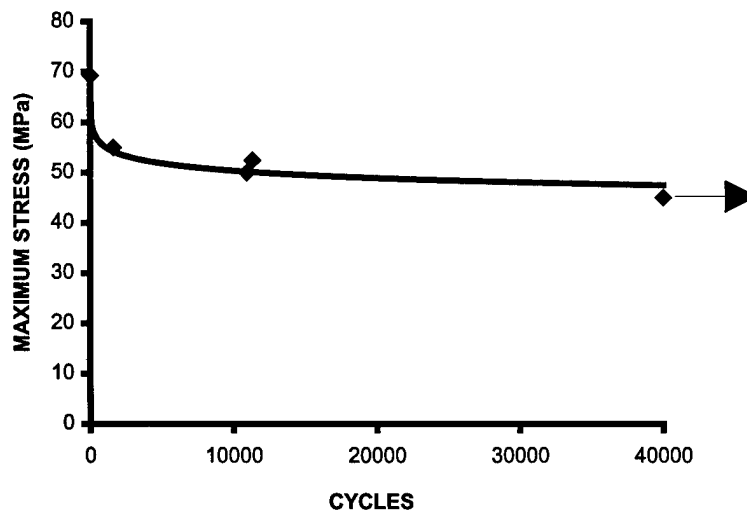
**Figure 4.5** Room Temperature Tension-Tension Fatigue Test S-N Curve

These tests were carried out at room temperature in normal laboratory conditions. The first test was started at a maximum stress level of 40MPa (about 60% of RT failure stress). The specimen survived 40,000 cycles and did not break. This number of cycles was considered as cycle run-out. The test was stopped at this number of cycles. The second test was at 45MPa maximum stress, and the specimen also survived 40,000 cycles and did not break. The third fatigue test was carried out at 50MPa maximum stress level. The specimen survived 10,922 cycles at this stress level. Two more tests were carried out at 52.5 and 55MPa maximum stress levels. The specimens survived 11,310 & 1,618 cycles at these two stress levels respectively. Figure 4.5 shows the S-N curve for these tests.

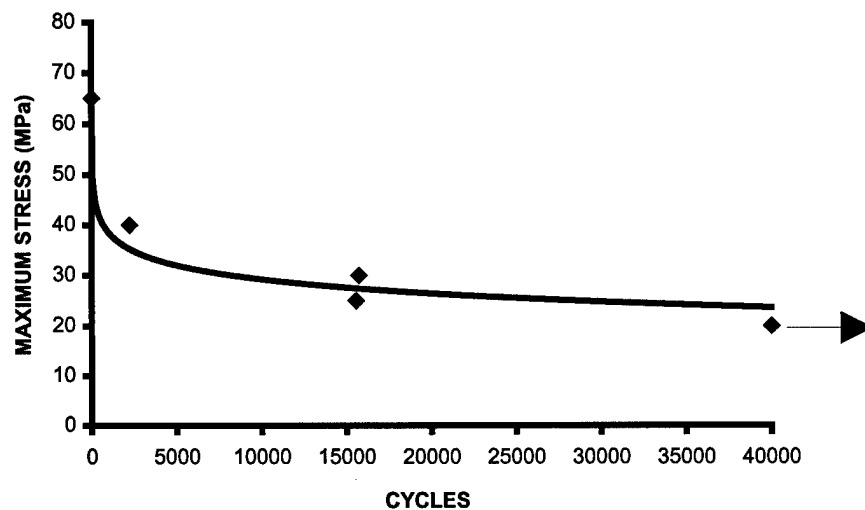
Figure 4.6 Elevated Temperature Tension-Tension Fatigue Tests S-N Curve

These tests were carried out at 760°C under normal laboratory conditions. The first test was carried out at 20MPa (about 40% of elevated temperature failure stress). The specimen survived 40,000 cycles and did not break. Three more fatigue tests were carried out at maximum stress levels of 25, 30, and 40MPa. The number of cycles to failure at these maximum stress levels was 15545, 15710, and 2210, respectively. Figure 4.6 shows the S-N curve for these tests.

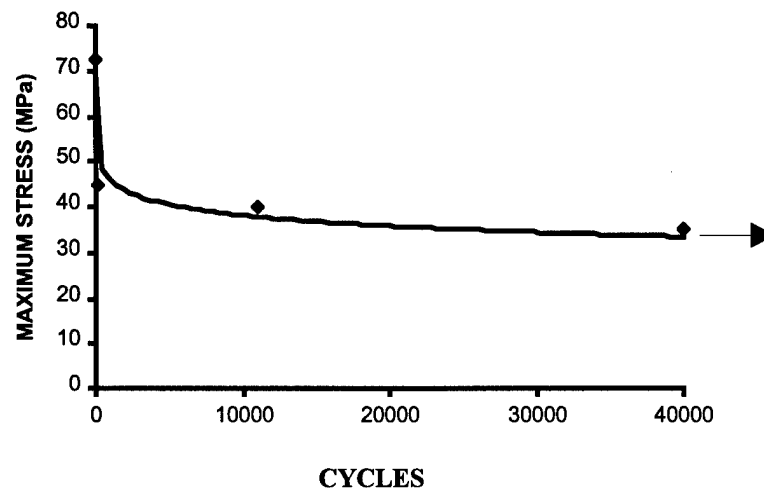
**Figure 4.7** Room Temperature Tension-Compression Fatigue Tests S-N Curve

These tests were carried out at room temperature in the ambient laboratory conditions. The first test was carried out at 30MPa maximum stress level. The specimen did not break at this stress level and survived the 40,000 cycle run-out. The second test was at 35MPa, and the specimen did not break at this stress level either. Two more tests were carried out at 40 & 45MPa maximum stress levels. The number of cycles to failure at these maximum stress levels were 11069 and 162, respectively. Figure 4.7 shows the S-N curve for these tests.

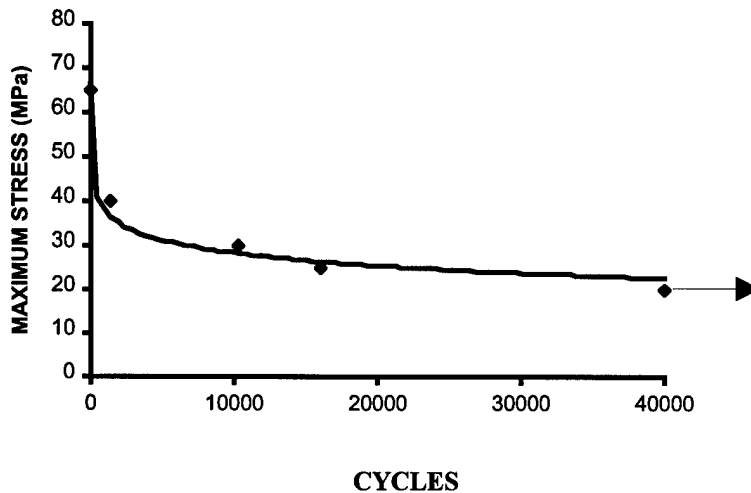
**Figure 4.8** Elevated Temperature Tension-Compression Fatigue Tests S-N Curve

out cycles were exceeded at this stress level and the specimen did not break. Three more tests of this kind were conducted at 25, 30, and 40MPa maximum stress level, and the number of cycles to failure was 16086, 10315, and 1407, respectively. Figure 4.8 shows the S-N curve for these tests.

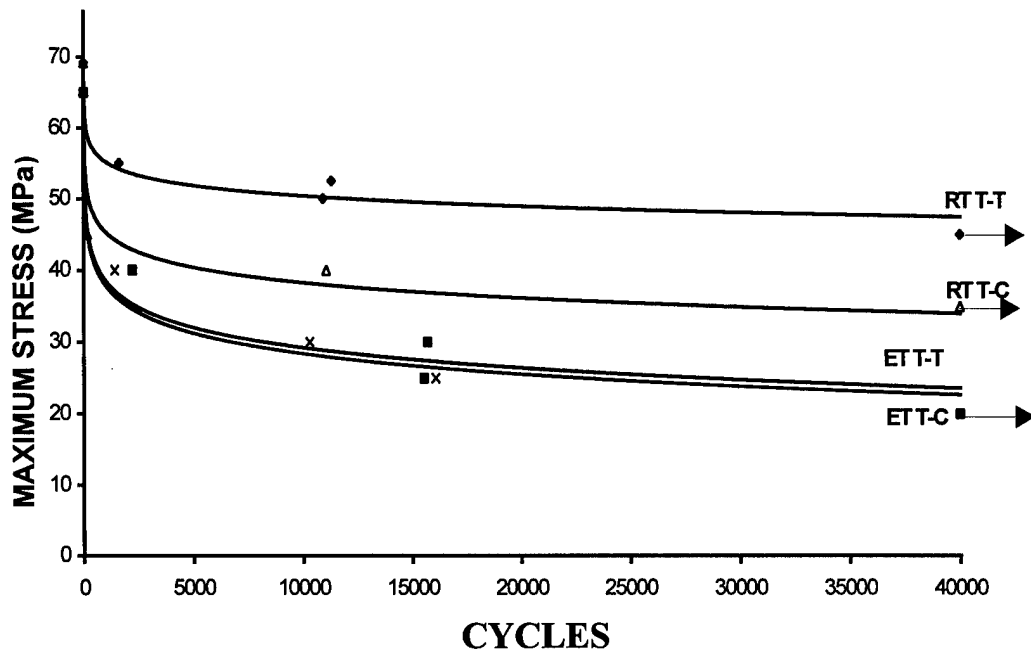
Figure 4.9 S-N Curves

At room temperature there is a significant difference between T-T & T-C fatigue life of the material under investigation. The number of cycles to failure at a given stress level in T-T is higher than in T-C, and the material can withstand higher maximum stress levels in T-T than in T-C. At the elevated temperature, it can be seen that there is practically no difference between T-T & T-C fatigue tests, and the material behaved almost exactly the same. In both T-T & T-C fatigue tests, the material can withstand higher maximum stress levels at room temperature than at the elevated temperature, indicating that more damage occurred in the material due to the elevated temperature.

The fatigue strength for 40,000 cycles at room temperature for the T-T fatigue tests is about 48MPa compared to 36MPa for the T-C fatigue tests. The corresponding value at the elevated temperature is about 24MPa for both T-T & T-C fatigue tests. So, the fatigue strength for 40,000 cycles is highest for the room temperature T-T fatigue tests, followed by the room temperature T-C fatigue tests, and lowest for the elevated temperature T-T & T-C tests.

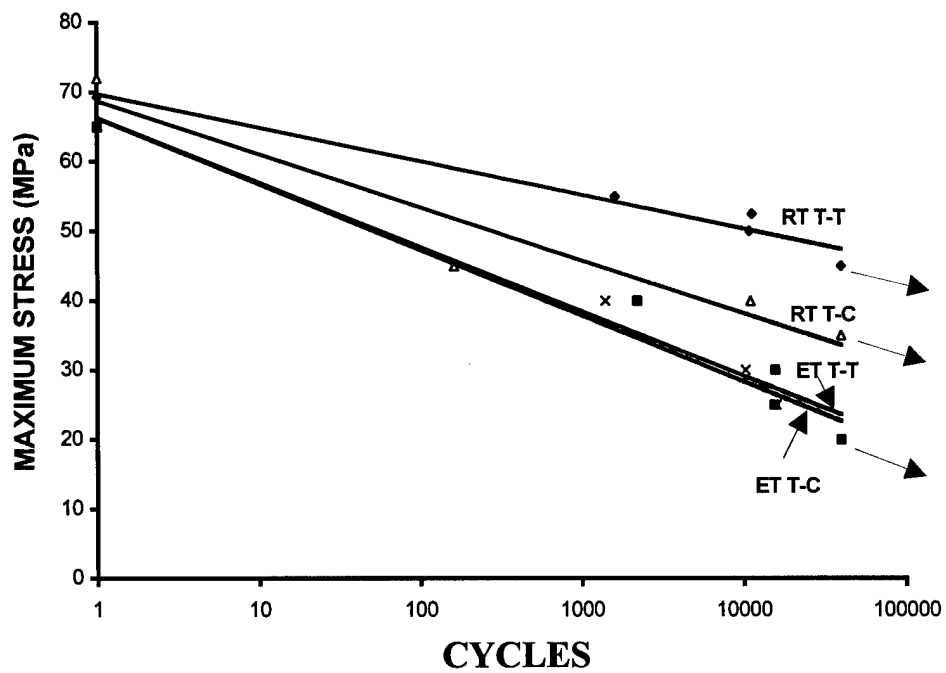
Figure 4.10 S-N Curves

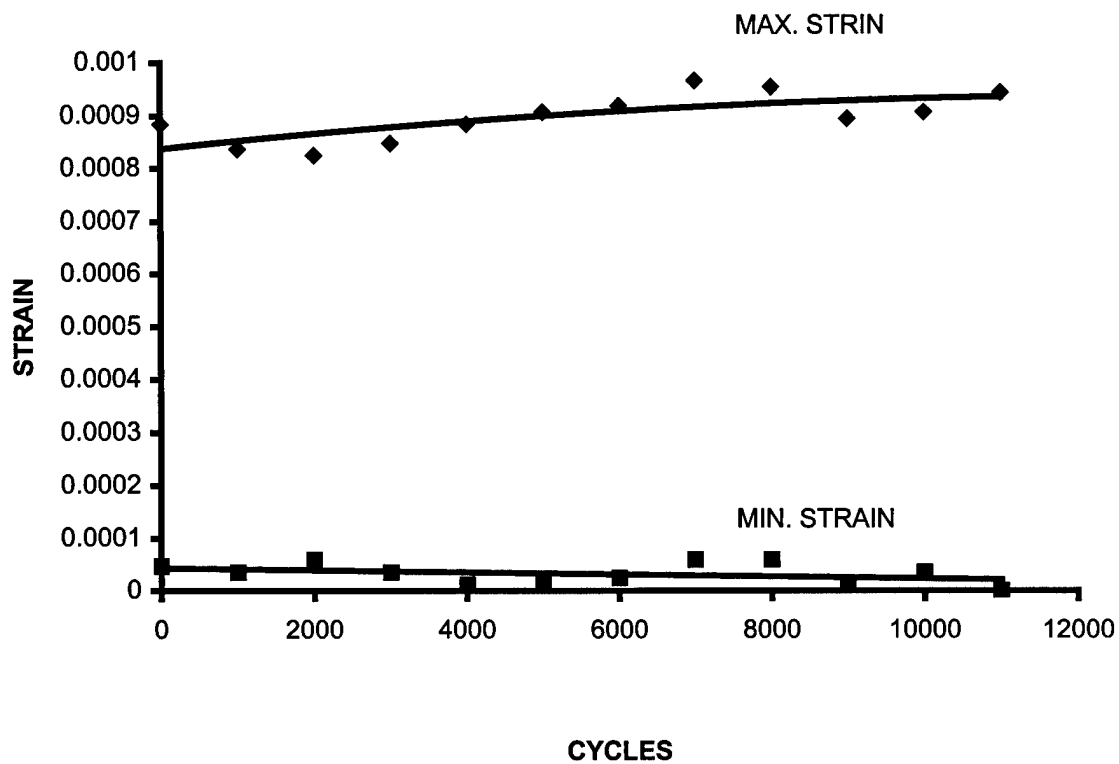
**Figure 4.11** 52.5MPa Room Temperature Tension-Tension Fatigue Test Min.and Max. Strain

Figure 4.11 shows the values of minimum and maximum strains for the 52.5MPa maximum stress room temperature tension-tension fatigue test. It can be seen clearly that there is no significant variation in both, minimum and maximum strain values from the onset of cycling until failure. The minimum strain is about 0.0035%, and the maximum strain is about 0.09%. These values of strain indicate that only little damage has occurred to the specimen in the first cycle, and much less damage occurred in the subsequent cycles up to failure. Figure 4.11 shows no signs of creep. This phenomena was also observed in the 55MPa room temperature tension-tension fatigue test with slightly higher minimum and maximum strains.

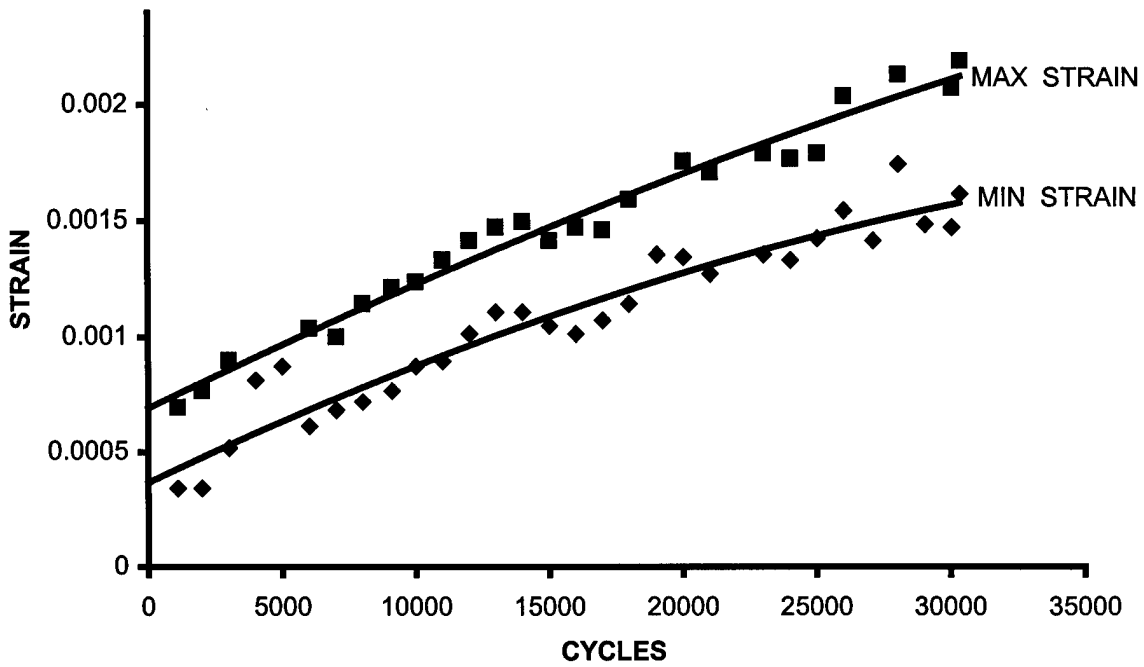
**Figure 4.12** 20MPa Elevated Temperature Tension-Tension Fatigue Test Min. and Max. Strain

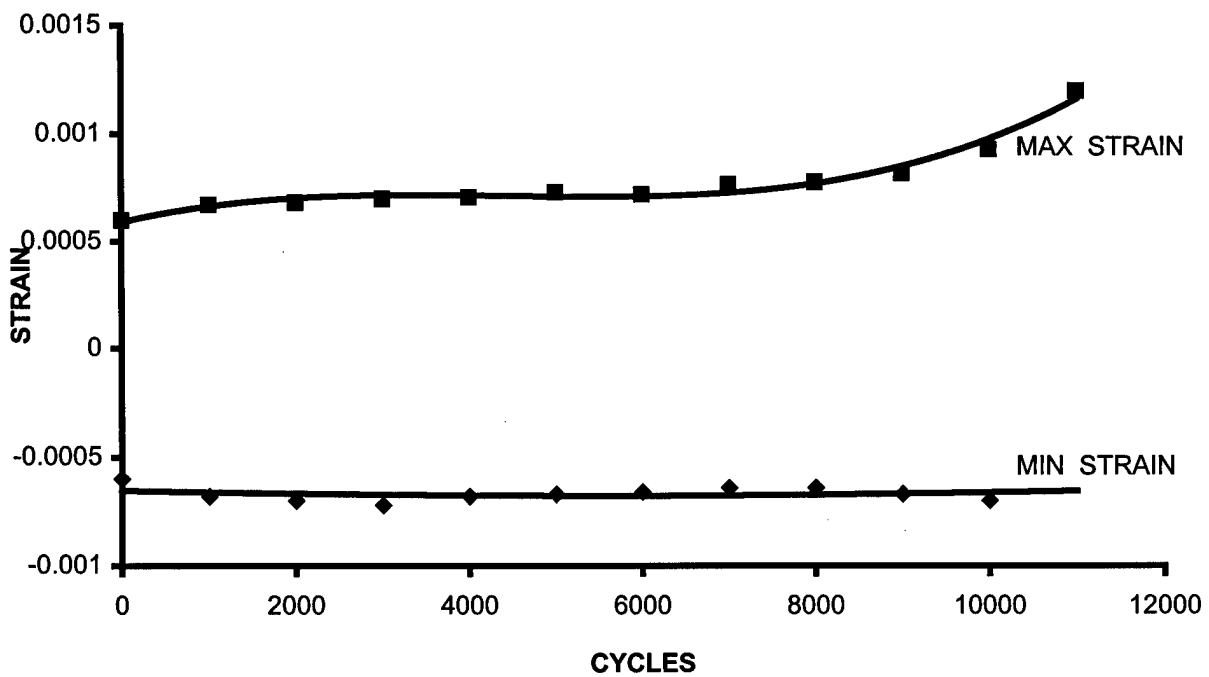
**Figure 4.13** 30MPa Room Temperature Tension-Compression Fatigue Test Min. and Max. Strain

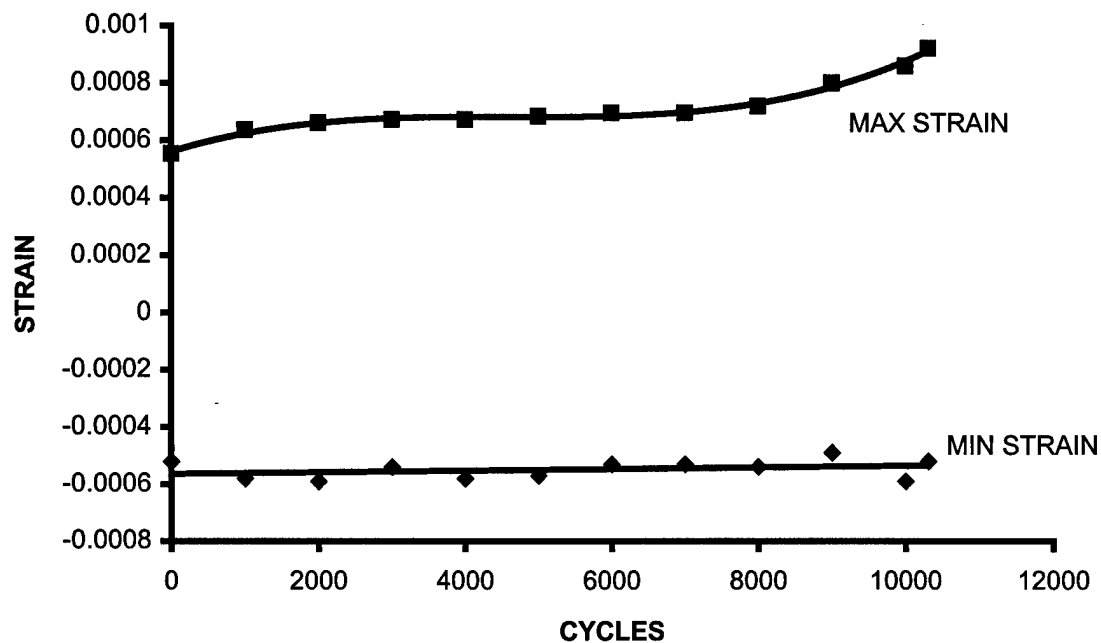
**Figure 4.14** 30MPa Elevated Temperature Tension-Compression Fatigue Test Min. and Max. Strain

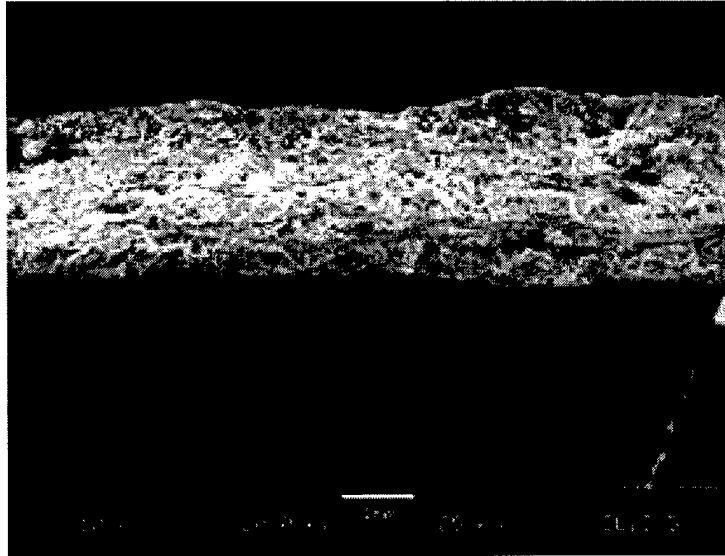
**Figure 4.16** Room Temp. Monotonic Tension Test Fracture Surface SEM, 12X

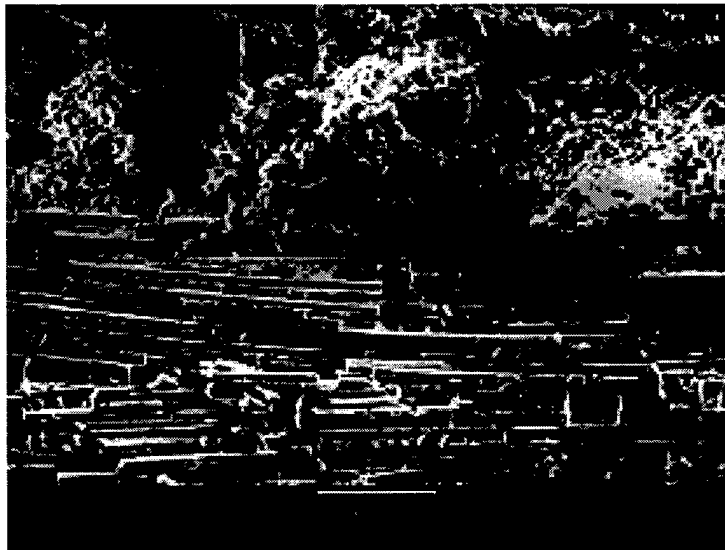
**Figure 4.17** Room Temp. Monotonic Tension Test Fracture Surface SEM, 200X

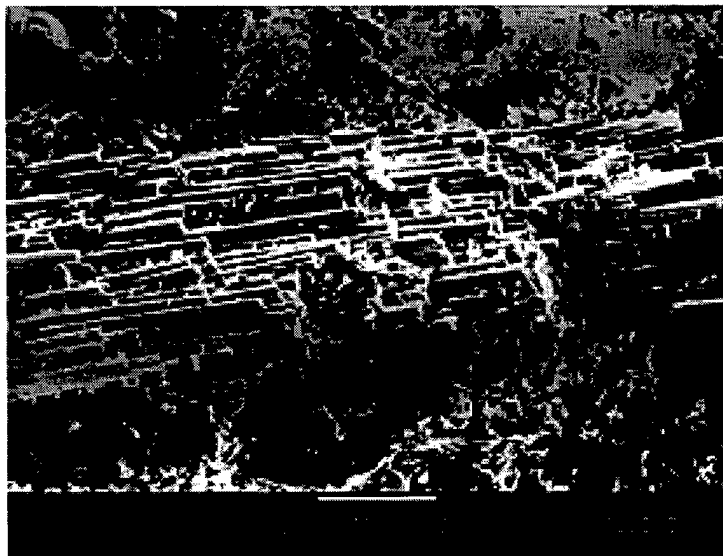
**Figure 4.22** Elevated Temp. Mono.Tensile Test Fracture Surface SEM, 200X

The fractured surface of the elevated temperature monotonic tensile test specimen is shown in Figure 4.19. Scanning Electron Micrographs of the elevated temperature test specimen fracture surface are shown in Figures 4.20-4.22. The elevated temperature fracture surface edges, as can be seen in Figures 4.19 and 4.20, are slightly rough compared to the room temperature fracture surface edges and have some jagged growth pattern. Fiber pull-out is clearly noticeable, as can be seen in the protruding 90° yarns in Figure 4.21. Figure 4.22 is a high magnification SEM photomicrograph and displays a high degree of 90° yarn splitting and fiber pull-out. These are also evidence of matrix cracking, interface debonding, and fiber break.

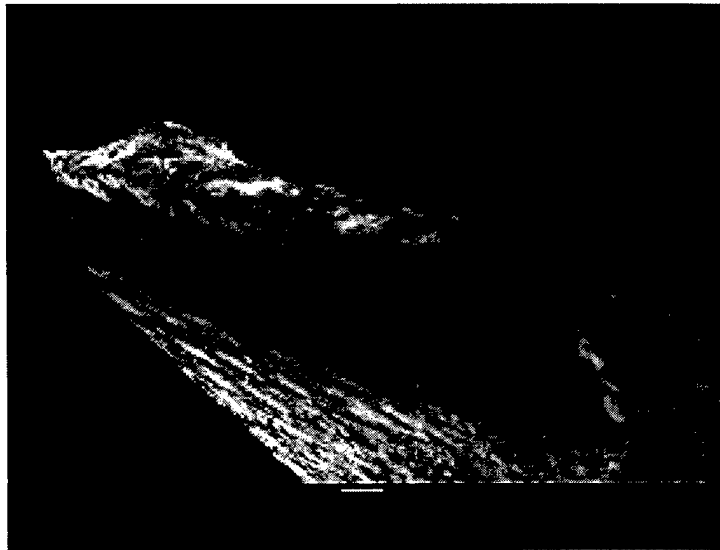
**Figure 4.24** Room Temperature Comp. Test Fracture surface SEM, 15X  
Cross-Section Rotated 45° CW

The fracture surface in this test as seen in figure 4.24 is very rough and is irregular. Both  $0^\circ$  &  $90^\circ$  yarns and matrix have broken. The matrix was crushed, and this was noticed as black powder coming out of the specimen at the fracture surface. Also, the specimen broke into pieces in the gage length, and these pieces came out of the upper and

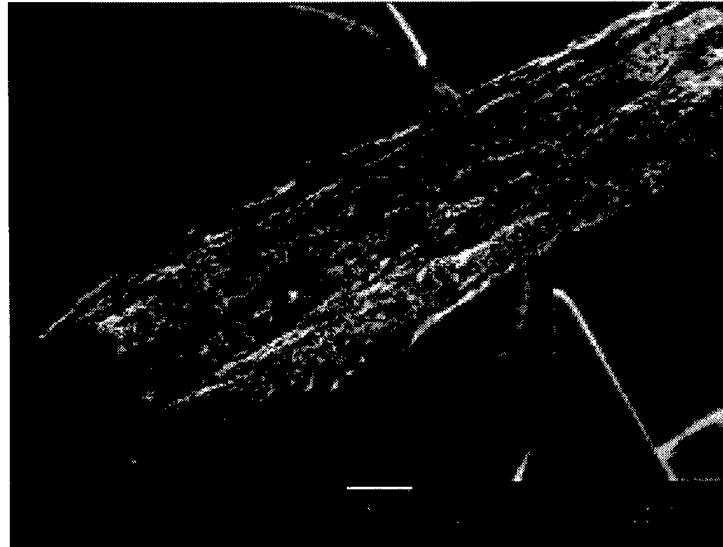
**Figure 4.28** Elevated Temp. Comp. Test Fracture Surface, SEM, 11X  
Cross-Section Rotated 45° CCW

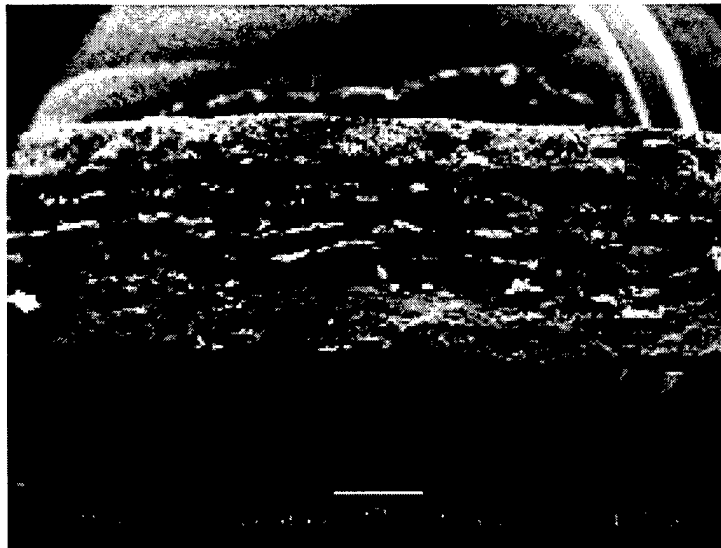
**Figure 4.55** 45MPa Room Temperature Tension-Compression  
Fatigue Test Fracture Surface SEM, 15X

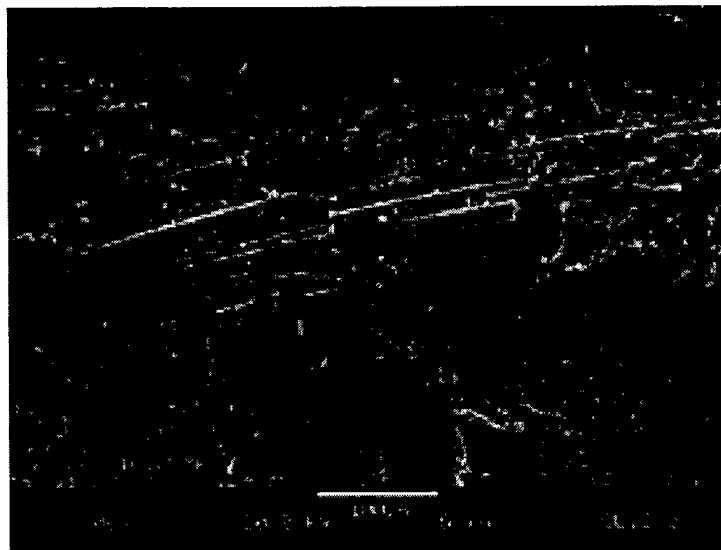
**Figure 4.67** 25MPa Elevated Temperature Tension-Compression  
Fatigue Test Fracture Surface SEM, 200X
